FIELD REVIEW REPORT

Date 06/14/05 Feature Crossed SCBL Load Rating HS20 MP 19.41
 Year Built 1990 Width 32'6 Length 69' No. of Spans 3 Cols/Bent 2
 CT Br. No. 36C0106 Dist. 04 Co. SCr Route Local Suff. Rate 87.2

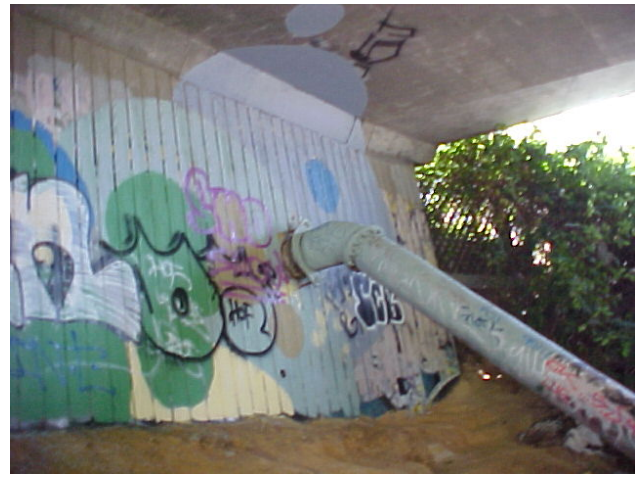
Restrainers/Soffit Opening Locations	None
Bridge Deck Overlays	AC overlay
Approaches	Slabs: None Railings: MBGR Sidewalks: 8 foot sidewalk on right side
Embankment Erosion	Minor undercutting of wingwall on right side of Abutment 1
Slope Paving	None
Construction access to structural components	Open
Unique Features	Geometry: ~90° curve in plan view Aesthetics: Finish on abutments, columns and wingwalls to appear as vertical wood planks
Visible Damage/ Deterioration	None noted
Existing facilities around structure (buildings, pumping plants, RR, etc.)	Residential housing
Visible Utilities	On: None visible Under: 12" dia. steel pipe extending out of the face of Abutment 4 Adjacent: Overhead electrical lines on each side of structure Street lighting electroliers
Roadway Conditions / Traffic Lanes	No. of Lanes: Two 12 foot traffic lanes Shoulders: None Median: None Drainage: Flows off low end of bridge Signage: 15 MPH curve warning sign Conditions: Fair Overlays: AC overlay Manholes: None

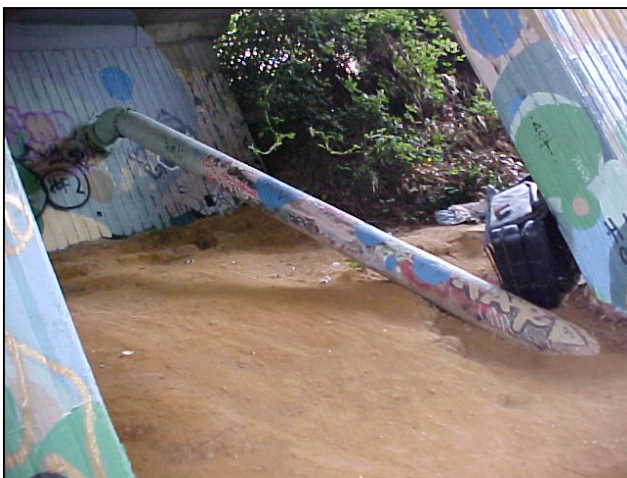
Abutment 1 Shoring Utility Conduit
