FIGURE 4

# Highway 9: Waterman Gap Hairpin Ccurve

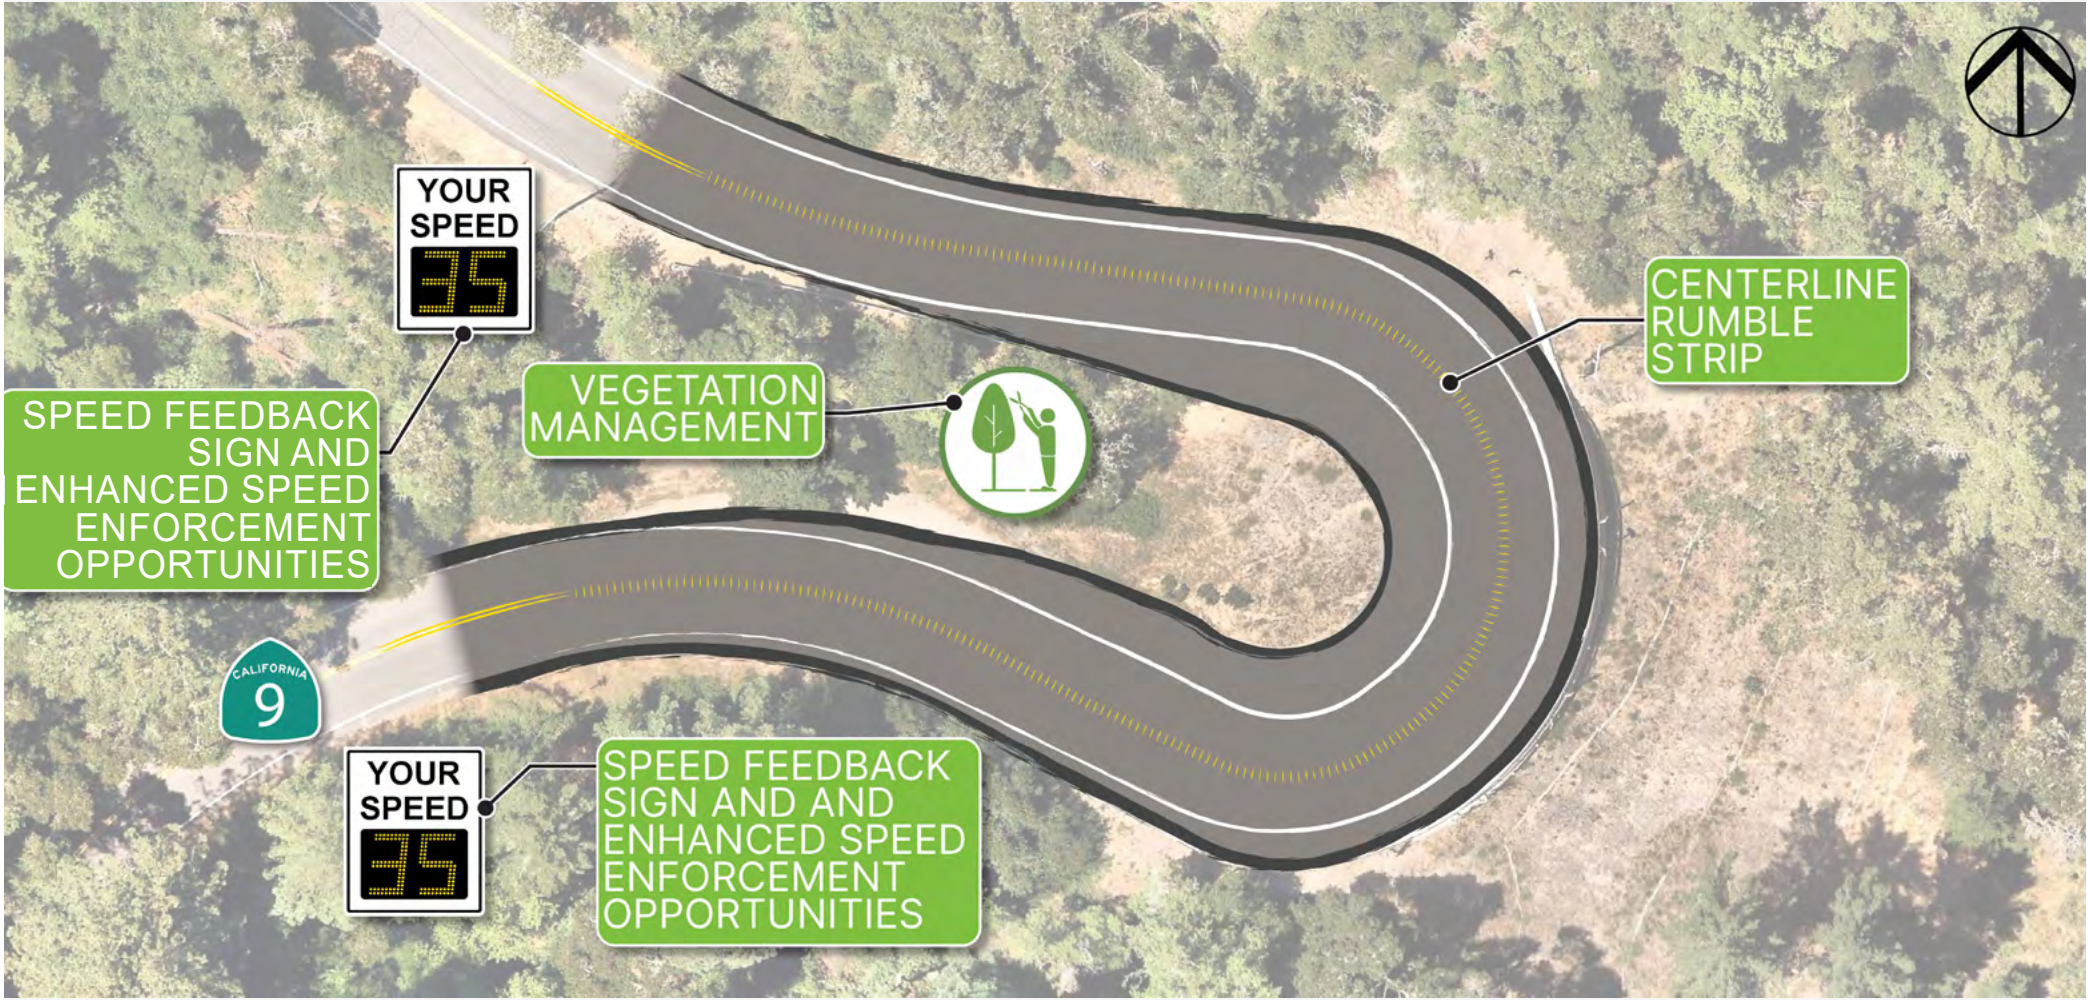
This segment of Highway 9, located at a hairpin turn south of the intersection with SR 236 and north of Saratoga Toll Road, is classified as Undeveloped Mountainous. The road is narrow with horizontal and vertical curves that present challenges related to sight distance, especially navigating tight or compounding curves. Anecdotal reports of speeding and racing on this portion of Highway 9 were shared in the community feedback. Although observed speed data shows average speeds of approximately 30 MPH, the corridor has a history of lane departure and DUI-related crashes.

- Install centerline rumble strips
- Manage vegetation to maintain visibility
- Install speed feedback signs to encourage slower travel speeds
- Enhance speed enforcement opportunities
